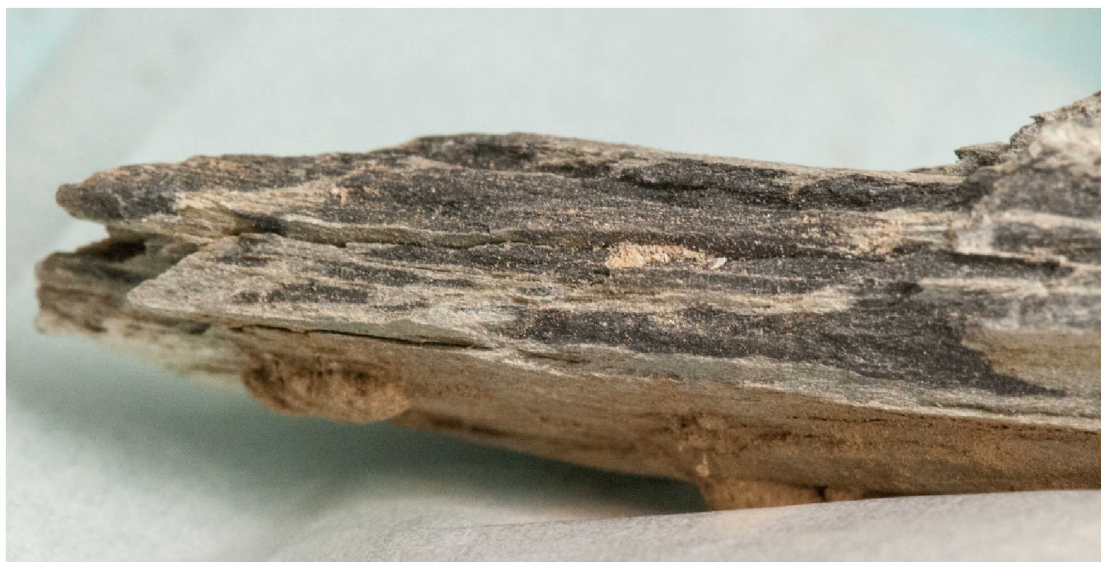
Here the rocks look similar to those seen at Location 3. The light gray-green color and the talc consistency layers observed at Location 1 were not observed here. The rock is more competent and also contains some of the quartz veinlets. At the end of cut (uphill), some of the altered greenish rock with needle-like structures along fractures was observed and sampled (12090113, see below). The rock is dark gray and shaley, and not visibly fibrous, but the thin green fractured surface could be different. No fibers were visible with hand lens, however.
